PDX Inspect inc.

Report Index

Test Maintenance Inspection

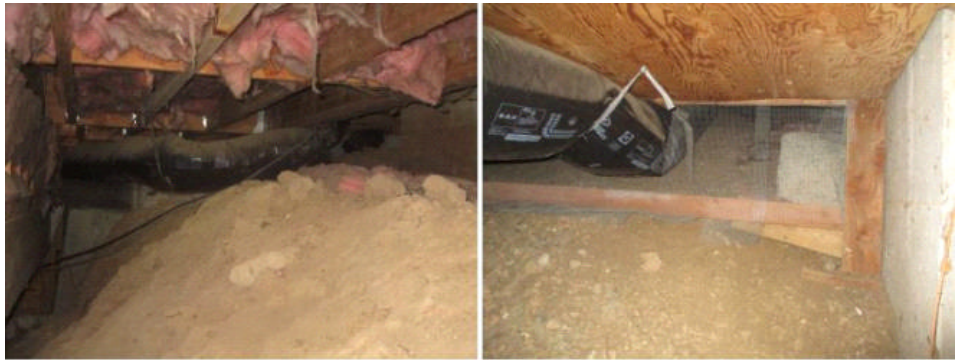
There are some areas of the crawlspace; due to the clearances and the size and amount of ducting and plumbing in a particular area, full and complete access was inhibited or blocked. The crawlspace was inspected as completely as possible, with the exception of these areas.

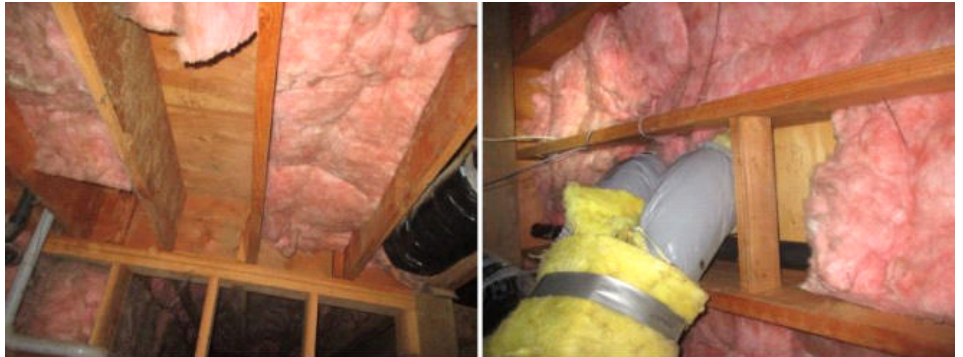
There is restricted clearance in the crawlspace and the flooring insulation is hanging and damaged. These two issues combined are significantly restricting both visual and physical access throughout the crawlspace. A reasonable attempt to inspect the crawlspace was made however; hidden or unapparent issues may exist due to the limited access.

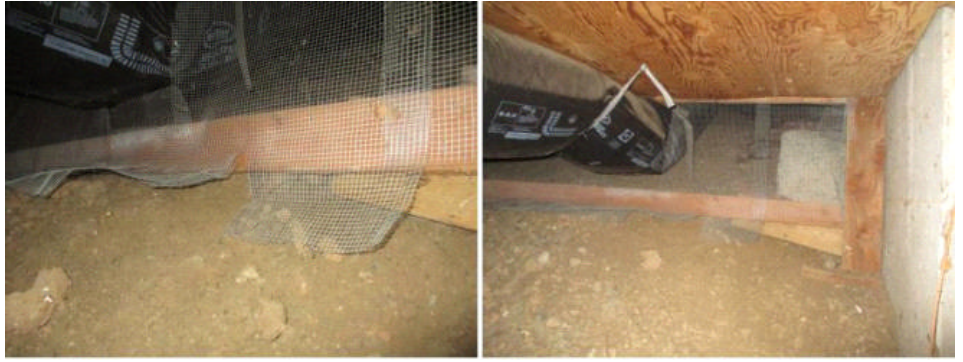
The under side of the house (crawlspace) is open along the rear half of the house. There is a 1/4" galvanized wire mesh that has been hung to inhibit animals from entering the front half of the under floor areas, but the mesh is laying on uneven ground and is not effectively preventing rodents from entering the crawlspace, storage, and under floor areas.

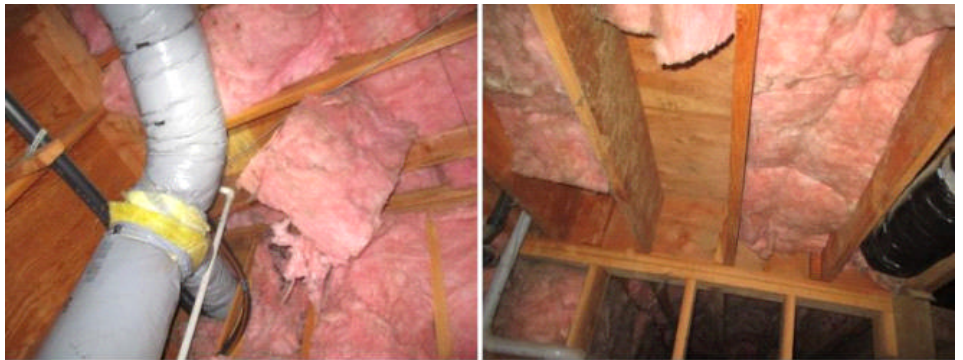
INSULATION & DUCTING There are areas where the floor insulation has been knocked or pulled down from the supports. It would be recommended to re-install and to secure these areas. There is no twine or batten to hold or support the flooring insulation. The insulation should be supported.
This is leaving some sections of the plumbing supply piping exposed and un-insulated.

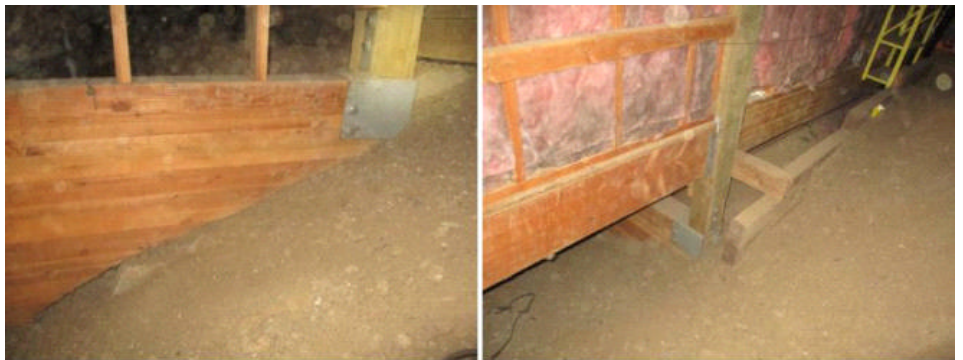
GRADING & ELEVATION There are posts and beams in the crawlspace that are partially buried. The grade should be pulled back or lowered to prevent wood to ground contact.

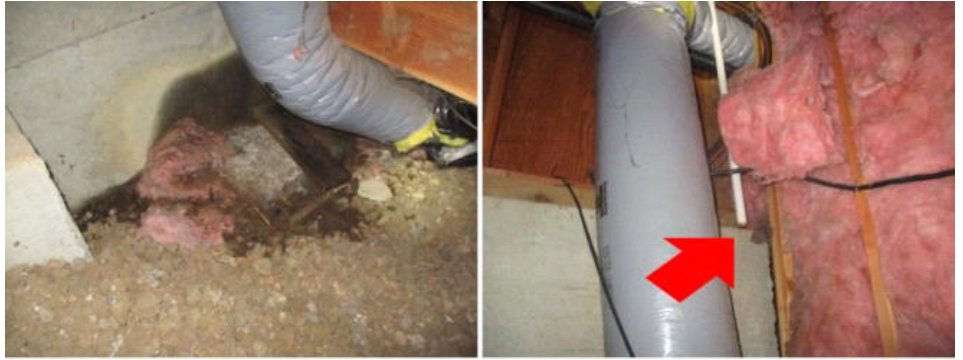
MOISTURE ISSUES & WATER DAMAGE The condensation drip line from the air conditioner is draining into the crawlspace. It would be recommended to pipe the condensation drip line out of the crawlspace, to eliminate adding moisture into this area.

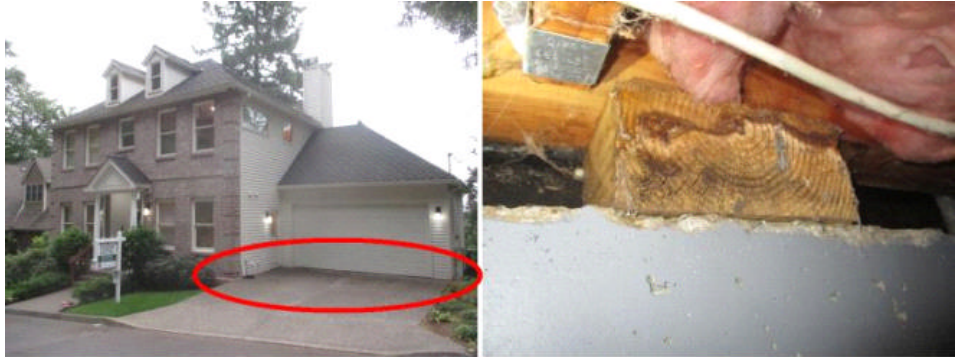
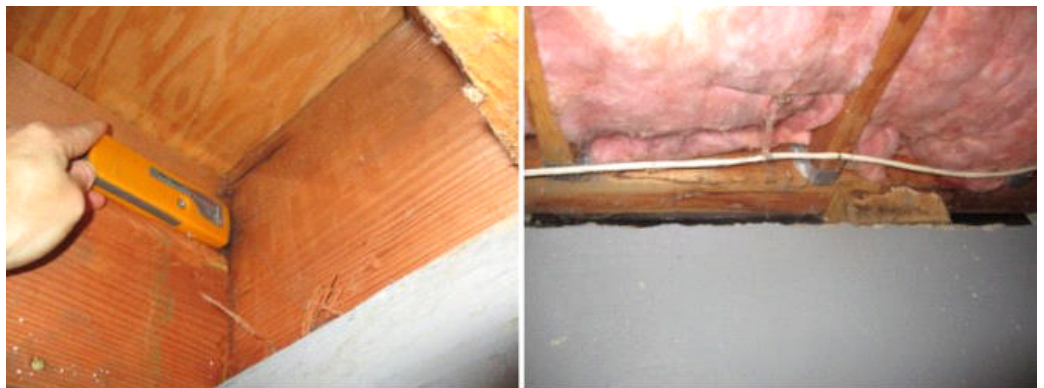
There are water stains or signs of active leaking into the crawlspace all along the area of the driveway attachment to the house and where the concrete driveway was poured over the siding on the side of the house. There is no current elevated moisture readings at the water stains in these areas; however, it does appear that leaking has been seasonal and reoccurring.

The concrete driveway slab is poured over the bottom course of the siding. This can trap moisture against the siding and lead to rot and damage. This intersection has been caulked, however caulking is a temporary seal and will require maintenance. The caulking is currently split or damaged in areas. This area should be periodically checked and maintained.

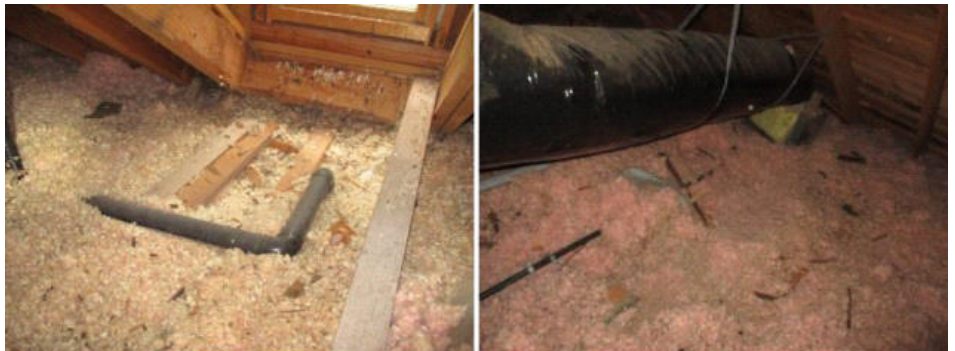
There is compacted or shifted areas of insulation in the attic due to "traffic" in the attic. There are foot trails through the insulation. This has diminished the thickness and R-Value of the insulation in these areas.

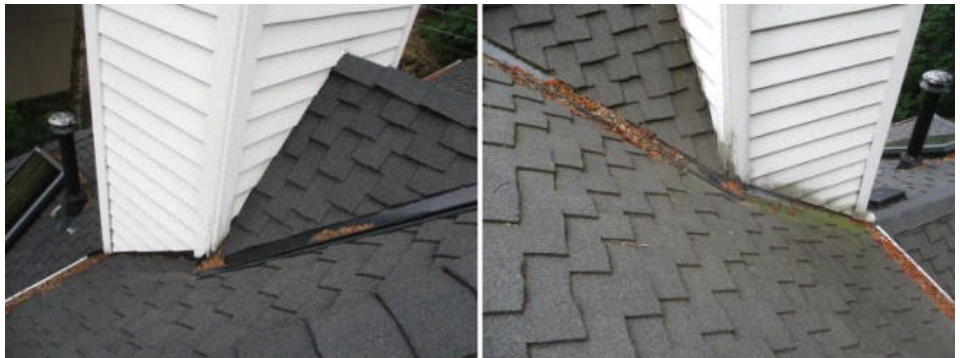
The wooden corner trim and siding on the chimney chase is fairly tight to the roofing. Debris is collecting behind the chimney and causing water to dam behind the chimney. This is causing moss and water damage to the bottom of corner trims and siding. It would be recommended to cut the corner trim and siding a minimum of 2" up off of the roofing to allow water and debris to flow around the chase without causing siding damage.

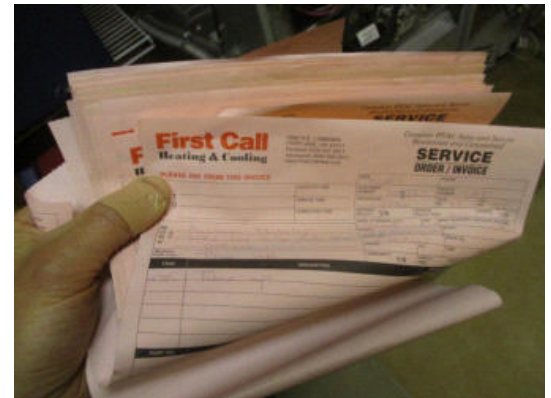
It is recommended to have the furnace & /or air conditioner checked and serviced no less than every two years. There are no current service records and furnace does not appear to have been cleaned or serviced in the past few years. The last indicated service repair or maintenance was on: 9/2012. It would be recommended to have the furnace checked and serviced by a licensed HVAC technician.

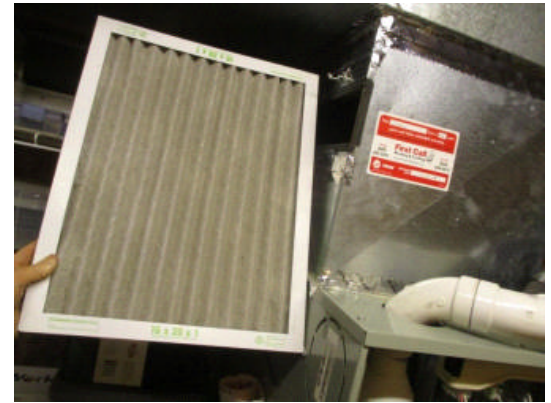
The furnace filter(s) are very dirty and should be cleaned or replaced.

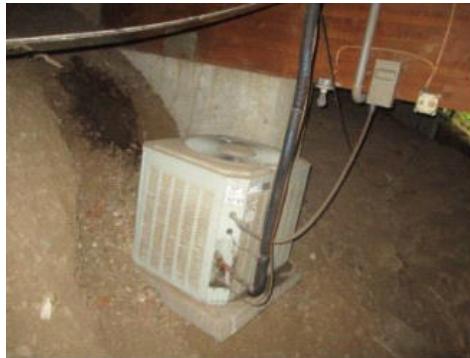
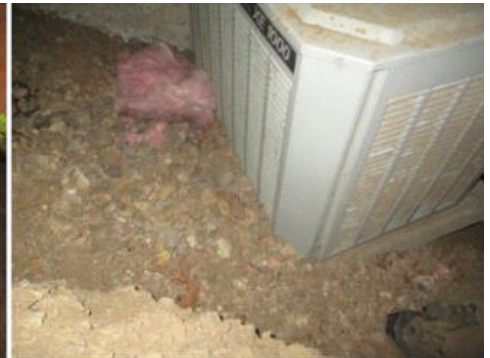
There is dirt and/or bark dust over the base of the compressor. It would be recommended to clear the grade from around the compressor to allow drainage around the compressor and prevent rust and damage to the compressor case.

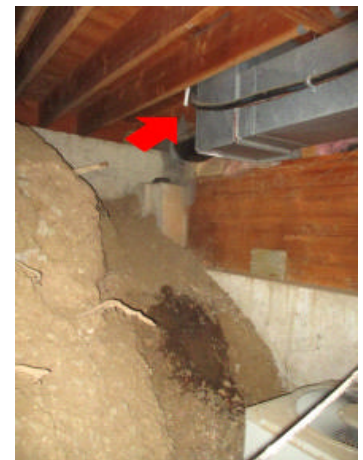
The condensation drip line from the air conditioner condenser unit is not piped out of the crawlspace. The condensation drip line should be plumbed out of the crawlspace.

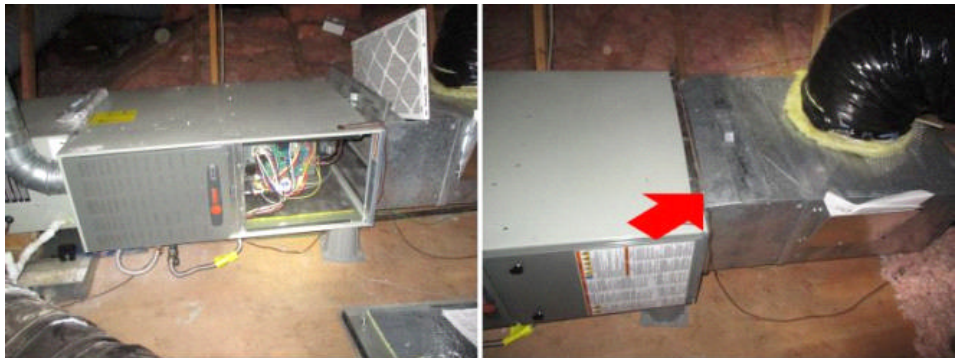
FILTER CONDITION: The air filter is installed at an access panel in the attic, located in the attic.
Consider installing a filter grill on the air return to allow the filter to be more easily accessed.

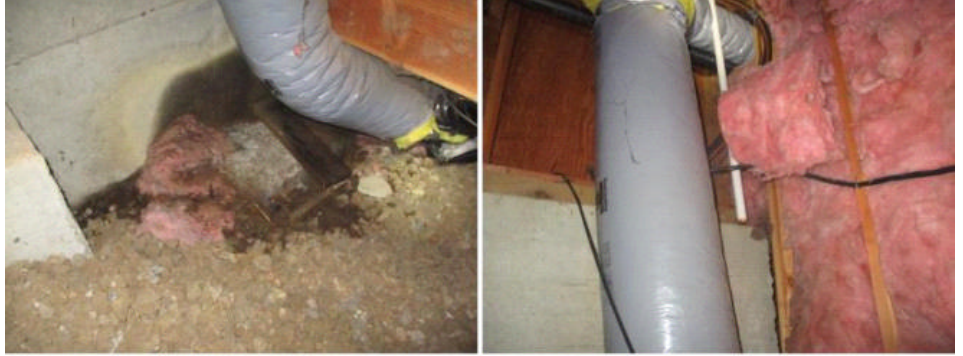
The condensation drip line from the air conditioner condenser unit is not piped out of the crawlspace. The condensation drip line should be plumbed out of the crawlspace.

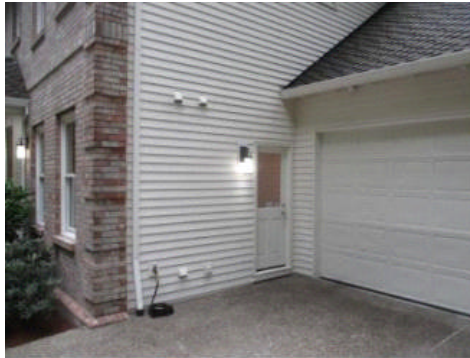
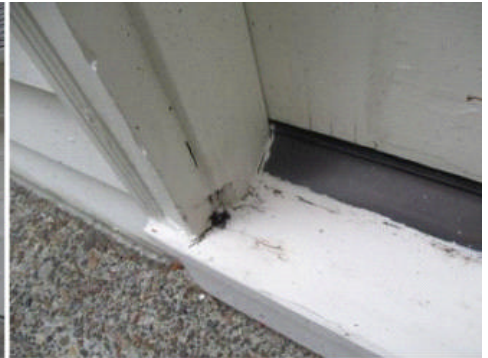
The joint between the threshold and frame is not sealed, which is allowing the end-grain of the door frame to wick moisture. The bottom of the doorframe rails are rotted or water damaged.

The finish on the door is significantly deteriorated and the door should be re-finished within the next 1 to 2 years.

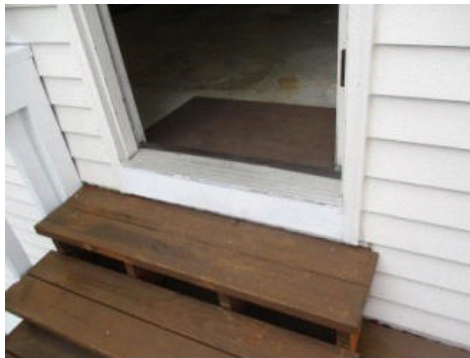
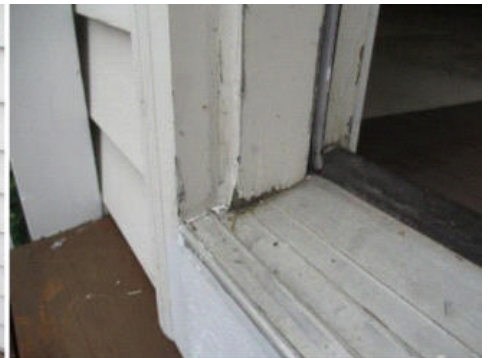
The joint between the threshold and frame is not sealed, which is allowing the end-grain of the doorframe to wick moisture. The bottom of the doorframe rails are rotted or water damaged.

The finish on the door is significantly deteriorated and the door should be re-finished within the next 1 to 2 years.

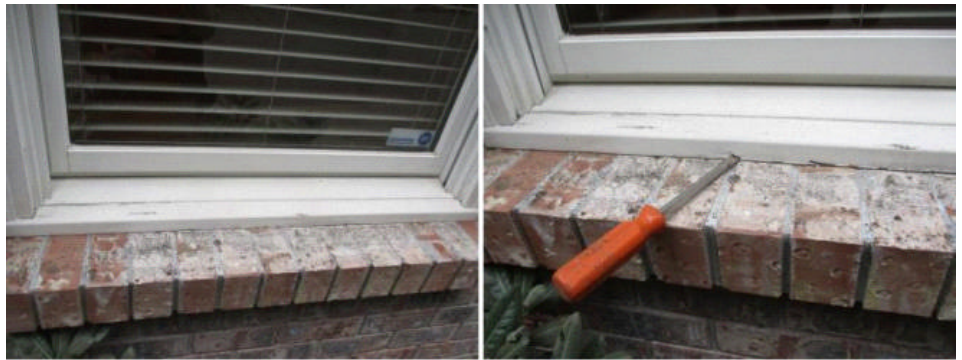
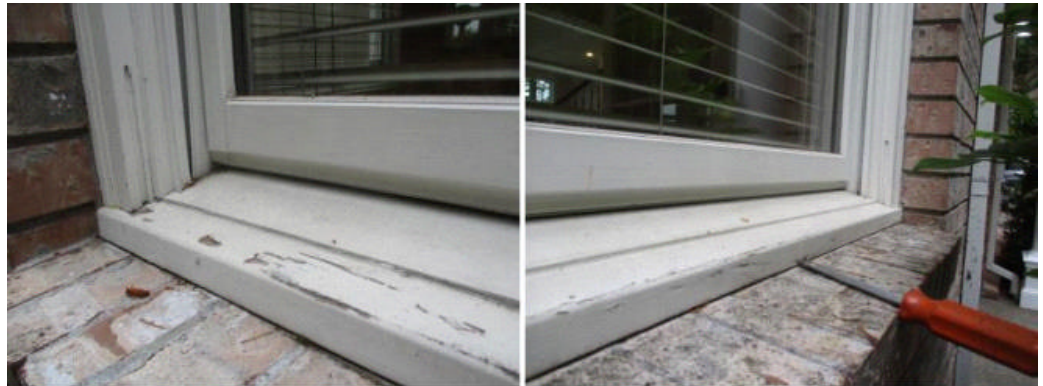
The sills of the front windows are rotted due to water intrusion and direct contact with the brick. It would be recommended to repair the decayed sills to prevent further deterioration and moisture intrusion.

It would be recommended to re-paint the wooden windows and repaint the wooden window trim within the next 1 to 2 years, to prevent moisture damage to the wooden windows, frames, and trim.

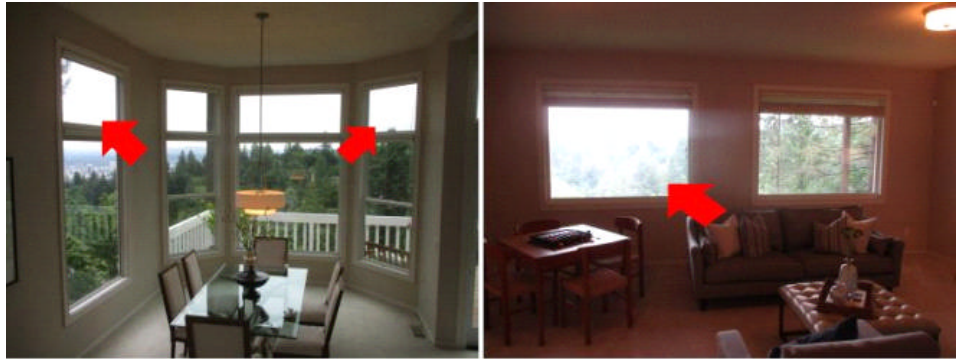
Fogging or evidence of failed window seals was noted at the following rooms or areas:
2 of the upper Dining Room windows, the Eastern window of the family room.

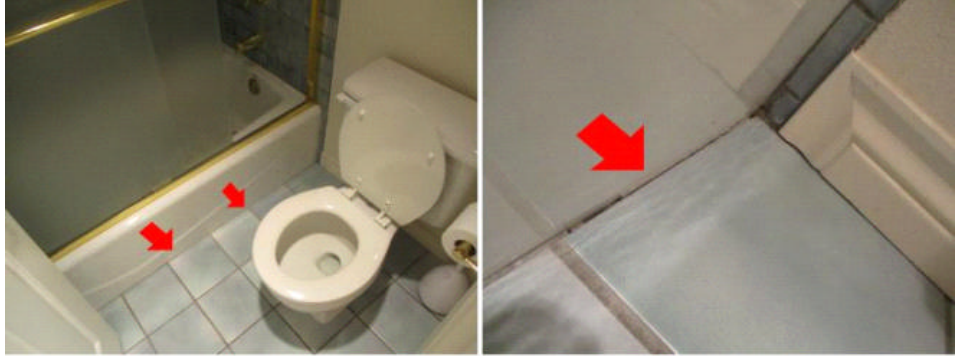
The grouted floor seam or intersection with the floor tile and tub and/or shower is not a water tight seal and will allow water intrusion. It would be recommended to caulk the floor to tub and/or shower intersection to prevent water intrusion.

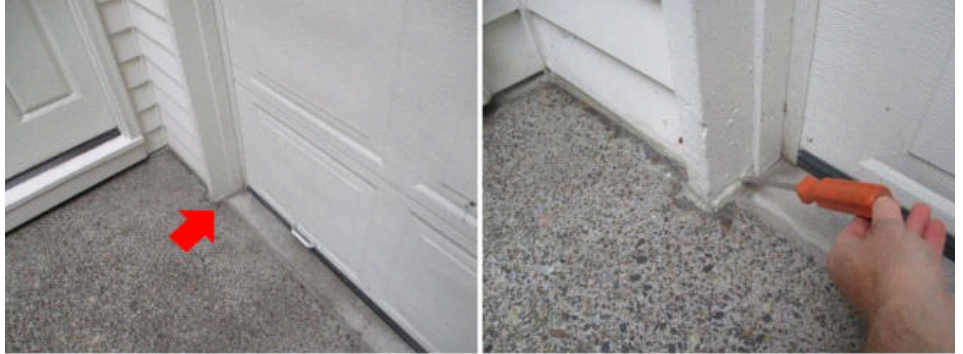
The garage door surround and trim is set in direct contact with the concrete driveway. The wooden trim is wicking moisture and has minor paint peeling and damage. It would be recommended to cut or trim the bottom of the garage surround trim 1/4" to 1/2" above the ground level to prevent direct contact with the ground.

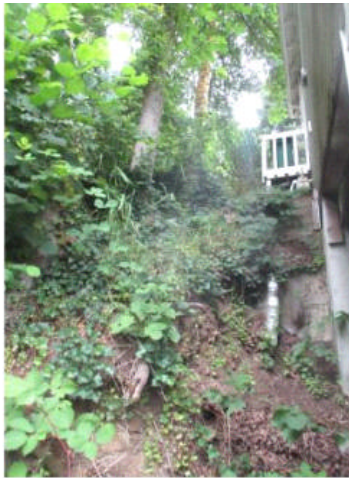
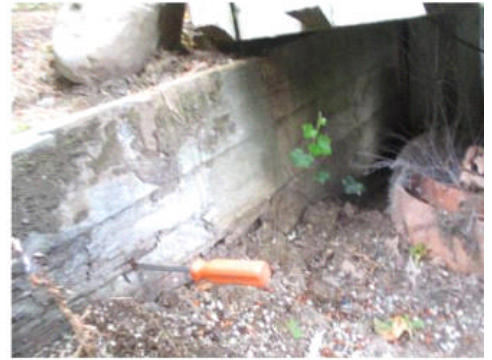
The wood of the two small wooden retaining wall system at the Western side of the garage is significantly deteriorated and rotted. Exposed wood rots from the inside out and the wood in contact with the ground is subject to rot below grade. These two factors conceal rot and damage until the wood is closely observed or probed, or the wood fails. Most of the timbers are significantly rotted. The timbers and main structure of the retaining wall are expected and need to be replaced within the next 1 to 2 years.

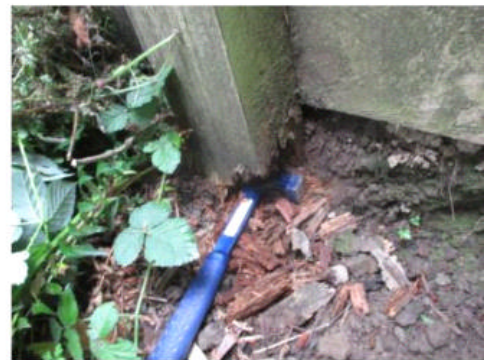
The post and rails of the 3 Eastern retaining walls are significantly rotted and are considered to have lost all structural integrity and should be replaced immediately.

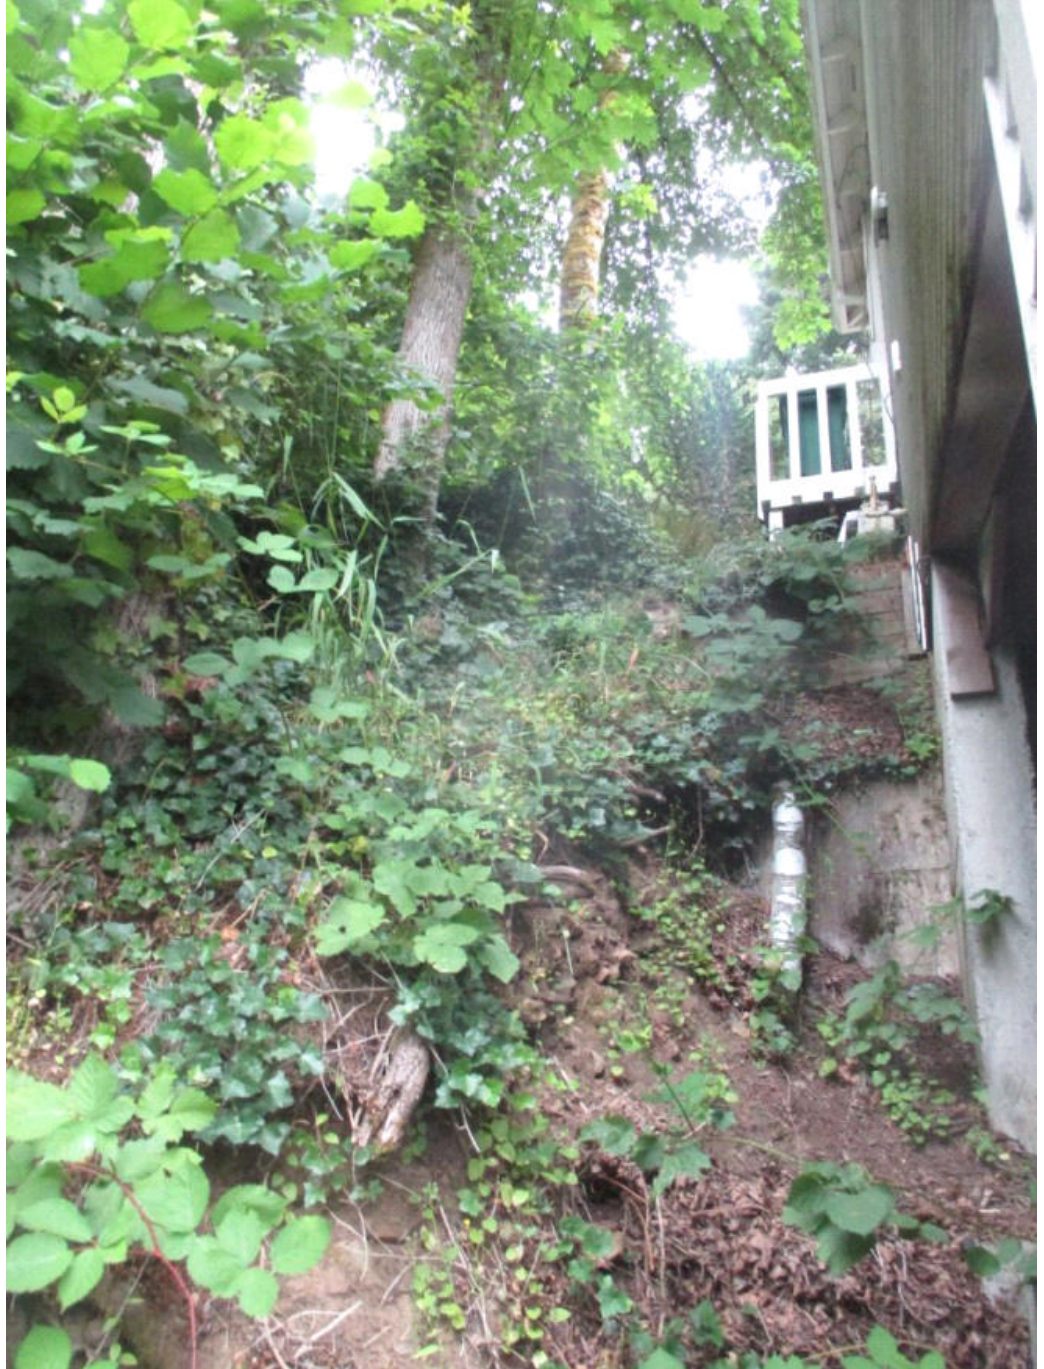
There is a large portion of the Western slope that is over a 45 degree slope, has multiple tall trees, was excavated, and is unsupported.

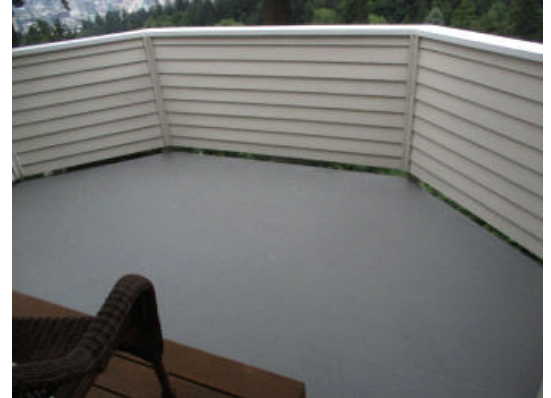
CONDITIONS: The deck surface has been recently painted. The coat of paint has several missing or poorly painted areas. The paint is not fully dry and the surface of the deck is sticky.

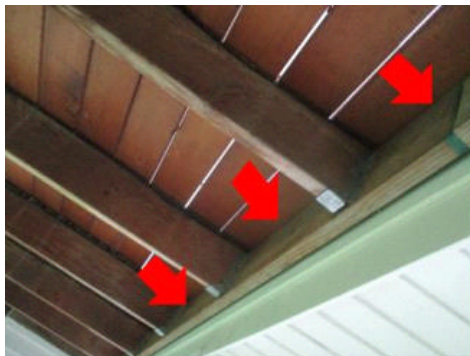
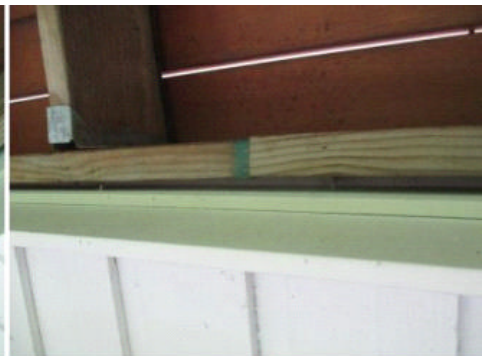
CONDITIONS : The deck ledger is installed over the top of the siding and is only supported by 16d (3-1/2") nails, which are only allowed if the deck ledger is attached directly to the wall. Additional lags, bolts, or anchors should be installed.

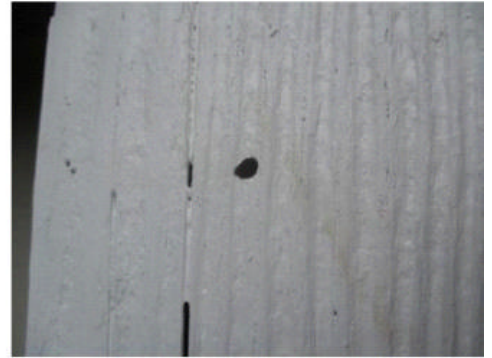
There is one wood boring beetle emergence hole and some decay in the center post.

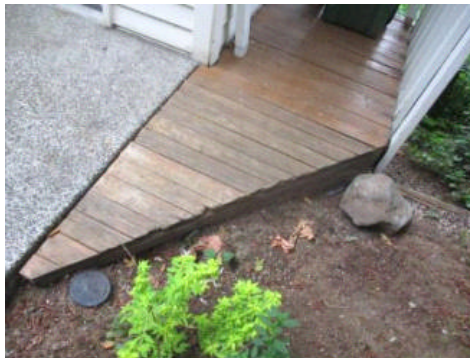
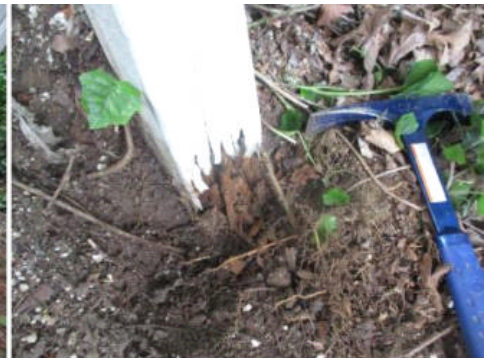
The deck has limited to no clearance to allow air movement or venting for the deck member under the joist. The limited clearance is also inhibiting a proper inspection of the decking and structure. Limited venting and air movement can cause moisture build up and cause accelerated deterioration to a deck or its structure. Portions of the deck structure are in direct contact with the ground or are buried. The low elevation of deck prevents or limits viewing or access under the deck structure. The deck structure and deck are deteriorated and damaged. The decking is not expected to safely support usage for more than a 2 to 3 year period. It would be recommended to replace any of the damaged or rotted decking or deck structure to prevent any serious accidents due to deck failure.

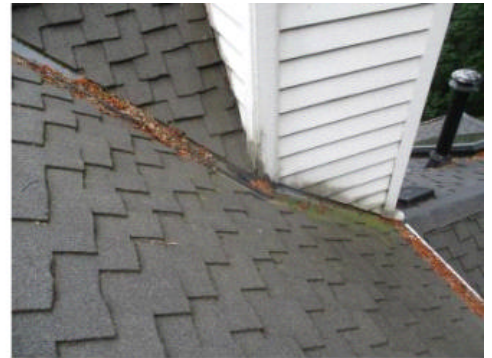
INSTALLATION ISSUES: The wooden corner trim and siding on the chimney chase is fairly tight to the roofing. Debris is collecting behind the chimney and causing water to dam behind the chimney. This is causing moss and water damage to the bottom of corner trims and siding. It would be recommended to cut the corner trim and siding a minimum of 2" up off of the roofing to allow water and debris to flow around the chase without causing siding damage.

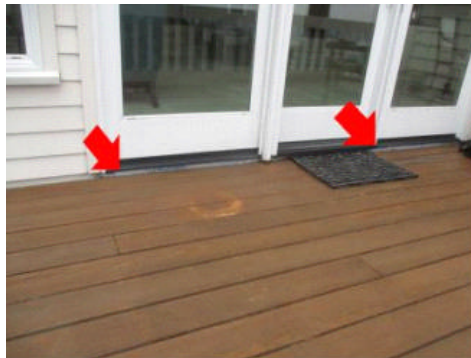
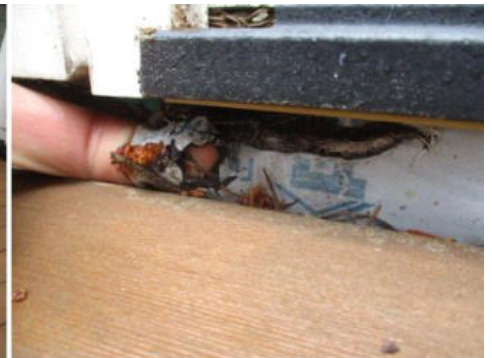
There is fortiflash exposed under the livingroom door. This material is not UV rated and should be covered.

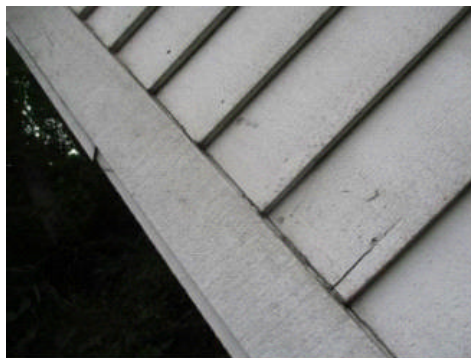
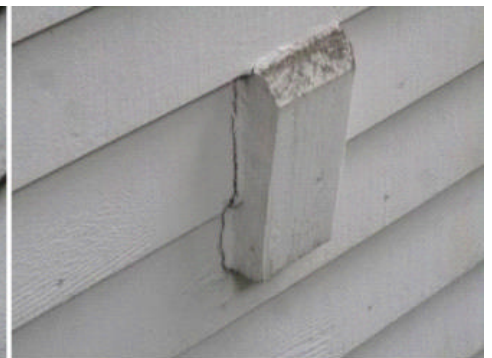
CAULKING CONDITION: There is some split, cracked or missing caulking in areas all around the house. It would be recommended to re-caulk and seal these splits or gaps.

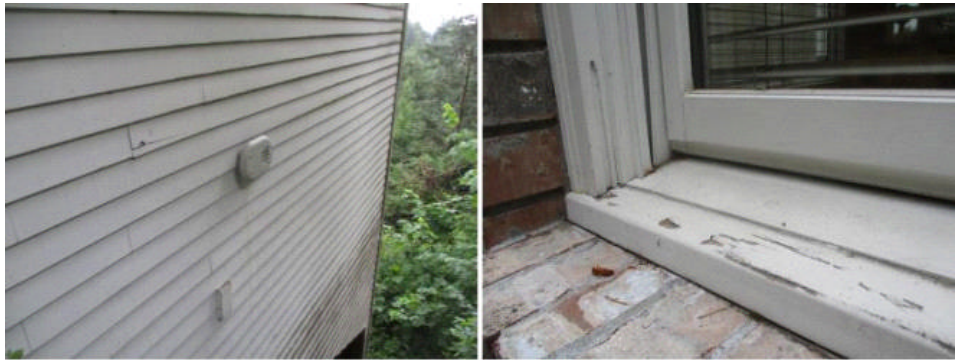
The paint on the house is in average condition for the age. There are some areas of minor splitting and peeling around the house, but the majority of the paint is in good condition. It would be recommended to re-paint the siding within the next 2 to 3 years. The paint on the wood trim is worn or split and peeling. It would be recommended to repaint the wooden trims within the next 1 to 2 years, to prevent moisture damage.

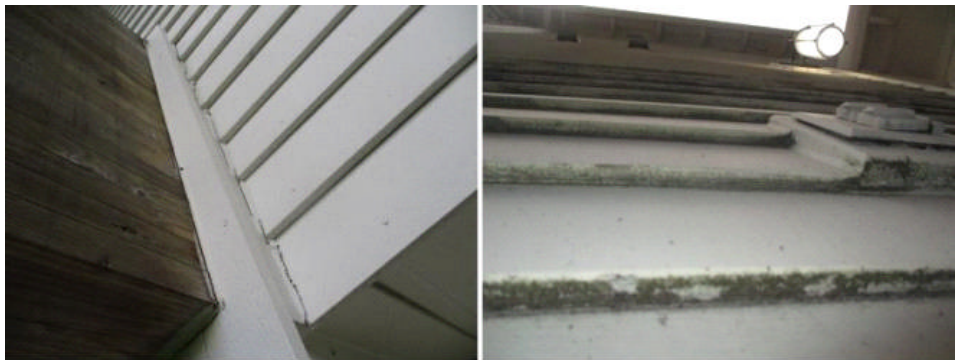
The bottom edges of the siding are not completely painted or sealed. This is an important area to have properly painted or sealed to prevent water damage, paint lifting, and peeling.

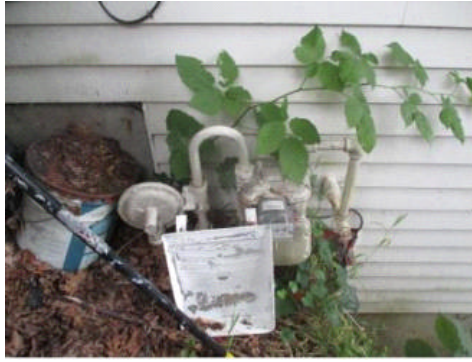
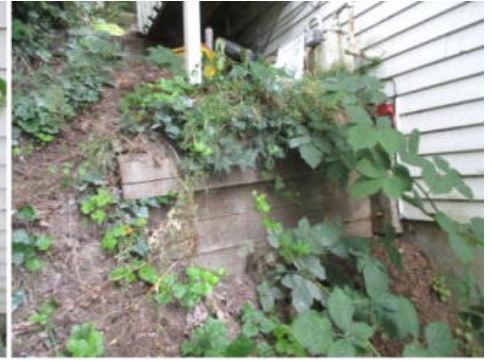
There is vegetation in contact with the structure, in areas around the house. The vegetation should be trimmed and kept 6 to 12 inches from the siding. The vegetation will hold moisture against the house and increase the likelihood of insect infestation.

The bottom of the siding is buried or even with the grade in areas around the house. The grade should be a minimum of 6" below the bottom edge of the siding. This is allowing moisture and water damage to the siding and paint. It is recommended to lower the grade and repair any damaged siding or paint.

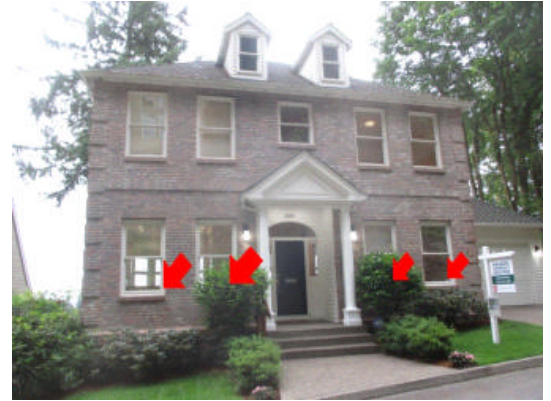
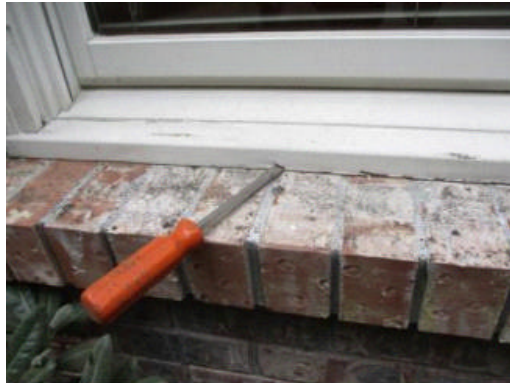
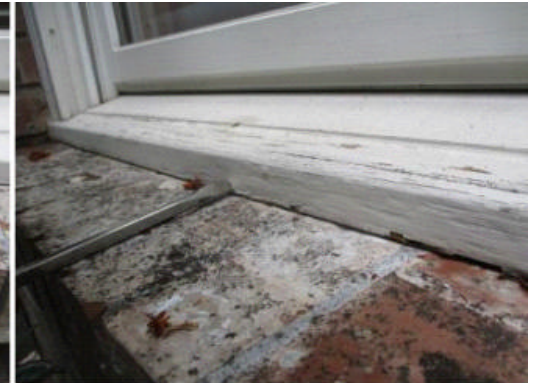
The sills of the front windows are rotted due to water intrusion and direct contact with the brick. It would be recommended to repair the decayed sills to prevent further deterioration and moisture intrusion.

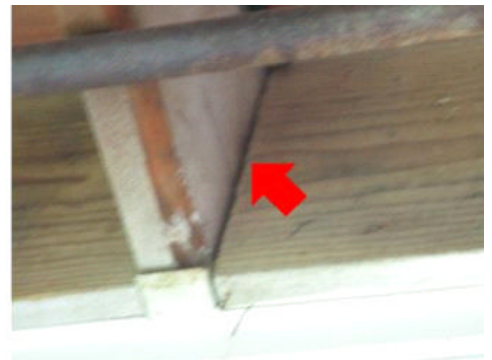
The deck joists of the main deck are cantilevered. The wall penetrations are unsealed and allowing some moisture intrusion into the wall structure. There are some water stains on the ceiling of the family room and along the tops of the family room windows. It would be recommended to fully seal around the joist wall penetrations.

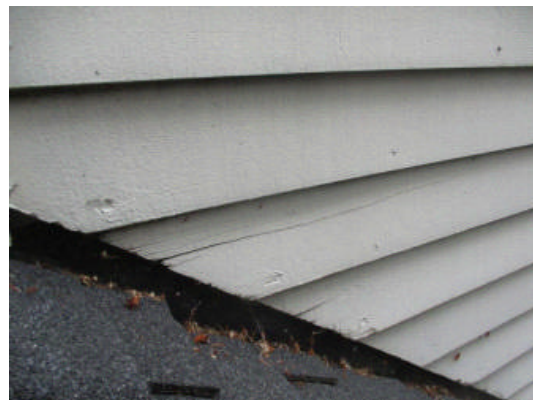
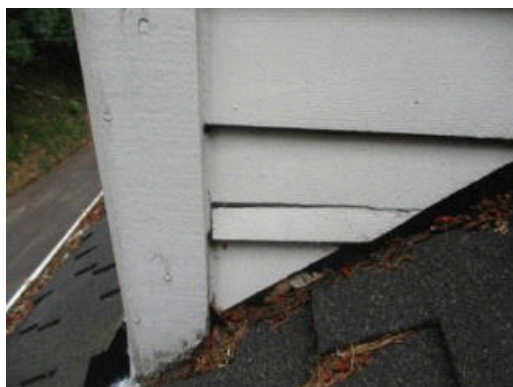
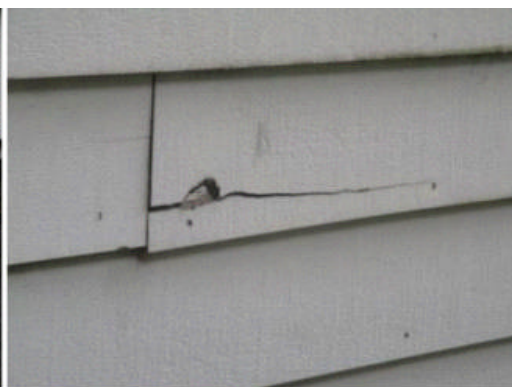
There are some split or cracked sections of siding. There are minor splits and damage at the edges of the siding (at the butt joints and corners). The damage is not extensive, but the split should be sealed or the damaged sections replaced. This damage is normal and expected age-relative damage. Corrections to this type of damage is considered part of normal house hold maintenance.

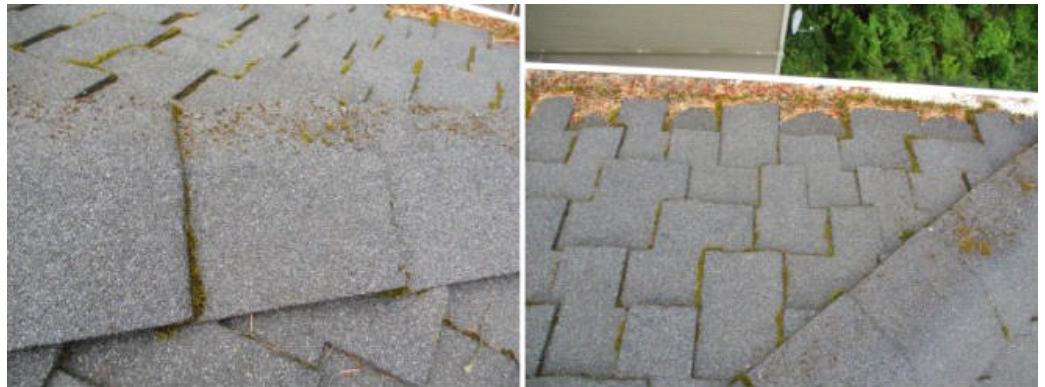
There is a build up of moss on the roof that should be cleaned and/or treated to facilitate the expected life of roofing.

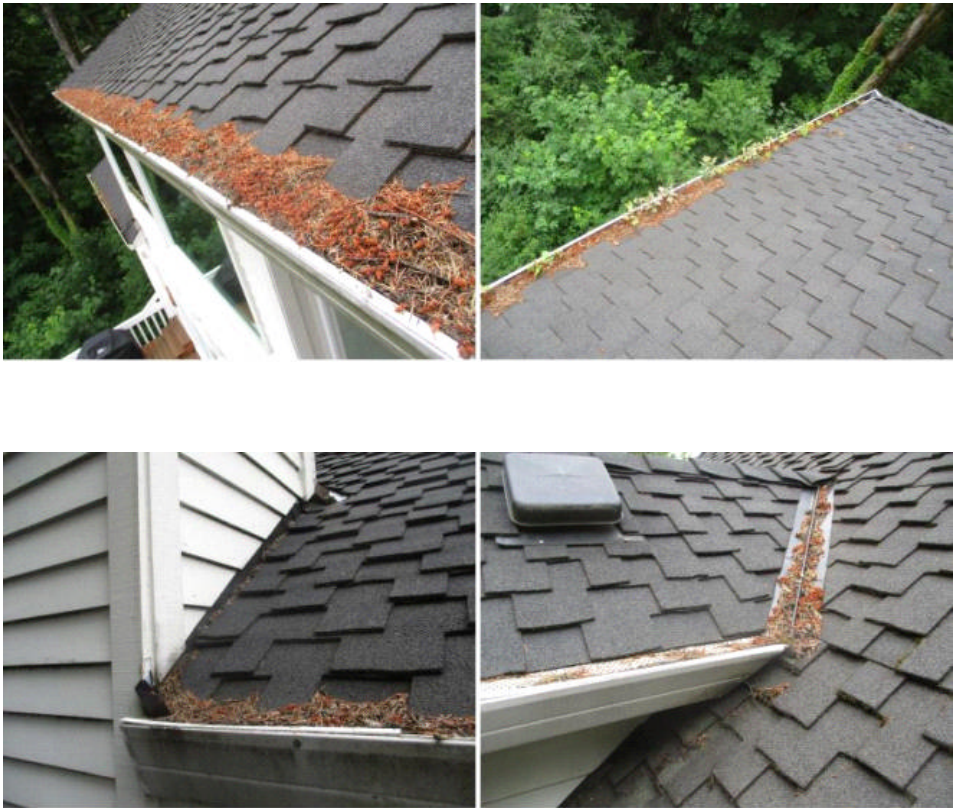
The gutters and downspouts are plugged with debris and overflowing during rainstorms. This can create moisture issued and erosion round the structure. The gutter and downspout openings should be cleared. Water is leaking out of the gutter through the gutter spike penetrations as well, this could lead to rot or damage in the rafter tails over time if the gutters are not kept clean.
