PDX Inspect inc.

Report Index

Test Maintenance Inspection

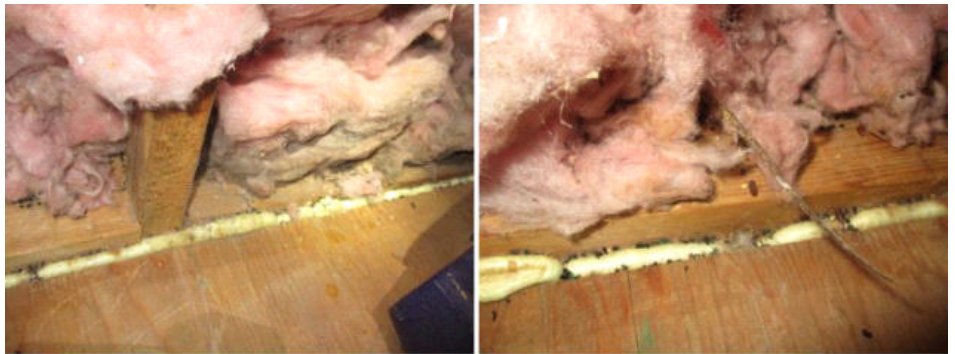
There were signs of rodent activity in the storage room.

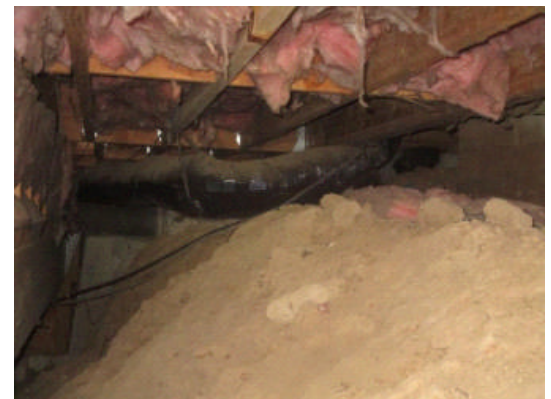
AIR PLENUM: The furnace ducting is lying on the ground in areas of the crawlspace. The ducting should be raised up off of the ground and supported.

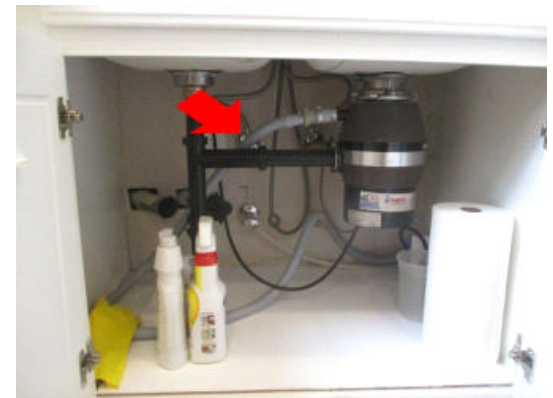
A proper air gap IS NOT installed in the dishwasher drain line. This can allow water to siphon from the disposal into the dishwasher. The drain hose of the dishwasher should have a loop that runs several inches above the garbage disposal.

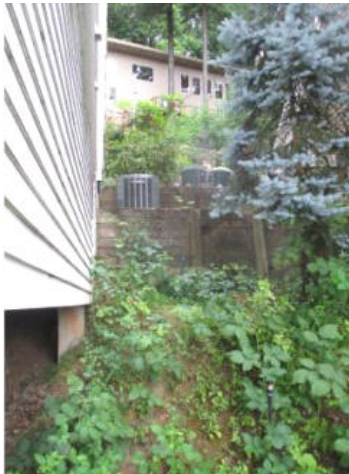
The post and rails of the 3 Eastern retaining walls are significantly rotted and are considered to have lost all structural integrity and should be replaced immediately.

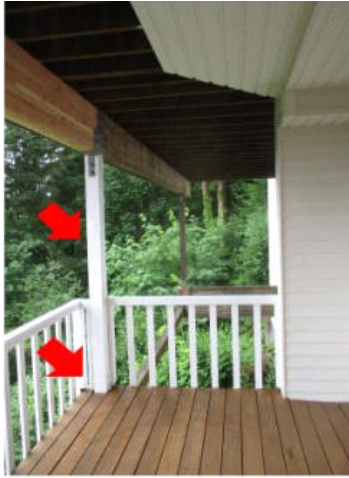
There is one wood boring beetle emergence hole and some decay in the center post.

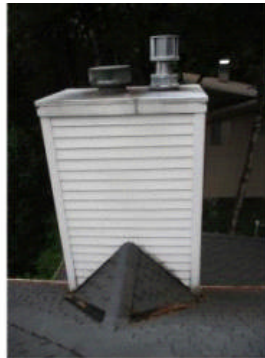
INSTALLATION ISSUES: The wooden corner trim and siding on the chimney chase is fairly tight to the roofing. Debris is collecting behind the chimney and causing water to dam behind the chimney. This is causing moss and water damage to the bottom of corner trims and siding. It would be recommended to cut the corner trim and siding a minimum of 2" up off of the roofing to allow water and debris to flow around the chase without causing siding damage.

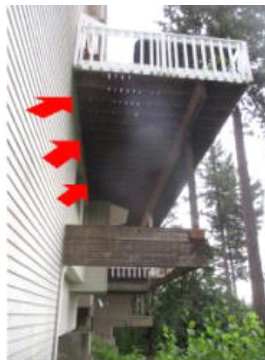
The deck joists of the main deck are cantilevered. The wall penetrations are unsealed and allowing some moisture intrusion into the wall structure. There are some water stains on the ceiling of the family room and along the tops of the family room windows. It would be recommended to fully seal around the joist wall penetrations.
